1963

VICTORIA

REPORT
OF
ROYAL COMMISSION
INTO THE
FAILURE OF KINGS BRIDGE

ROYAL COMMISSION OF ENQUIRY INTO THE FAILURE OF KINGS BRIDGE

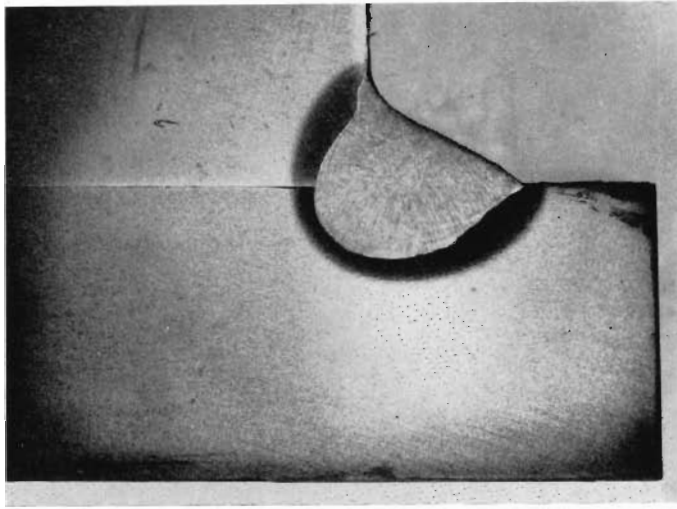
Automatic longitudinal weld—cover plate to flange.
(Girder W.14-S.4, south end.)

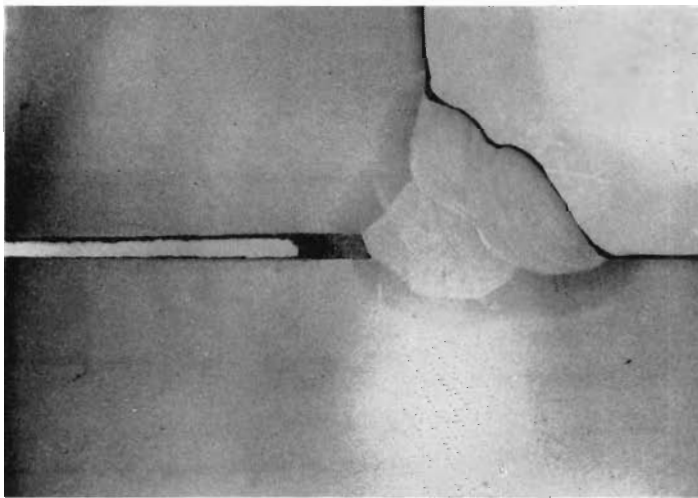
Manual taper weld—cover plate to flange.
The gap between cover plate and flange was greater in this section than in any of the others examined to date.
(Girder W.14-S.1, north end.)

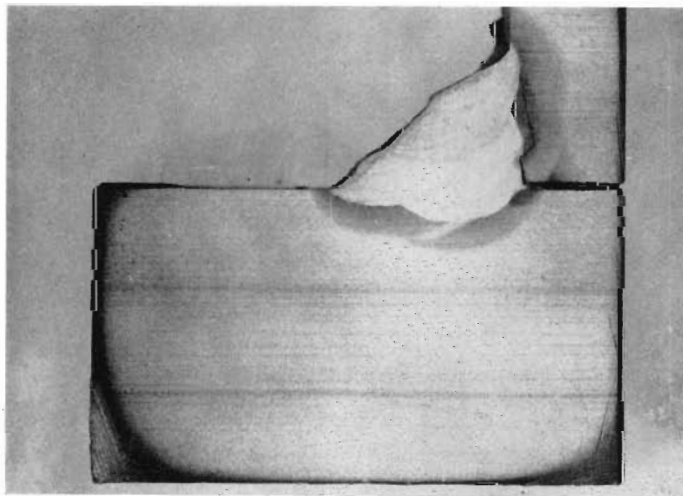
Manual transverse weld—cover plate to flange.
(Girder W.14-S.1, north end.)

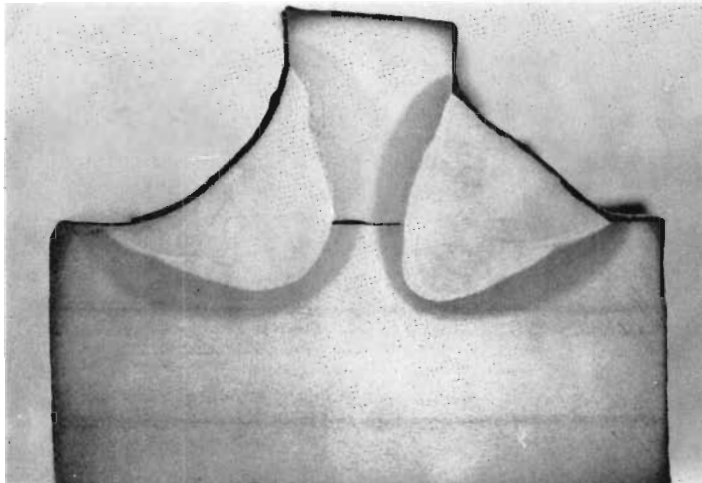
Automatic longitudinal weld—web to flange.
(Girder W.14-S.1, north end.)

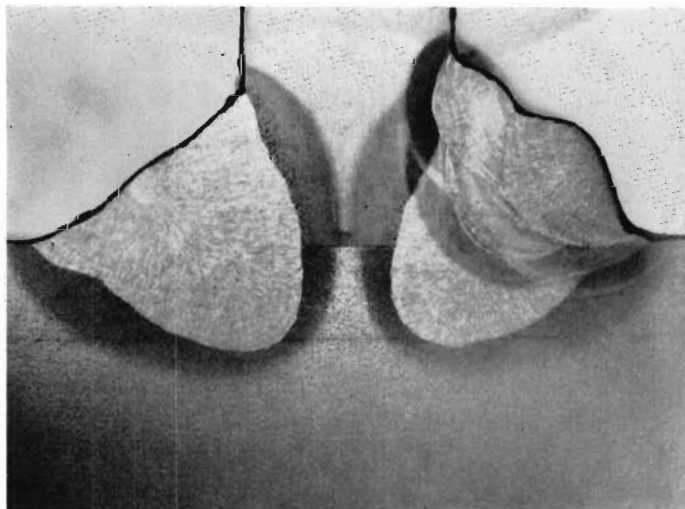
Web to flange weld, repaired by manual welding.
(Girder W.14-S.3, north end.)

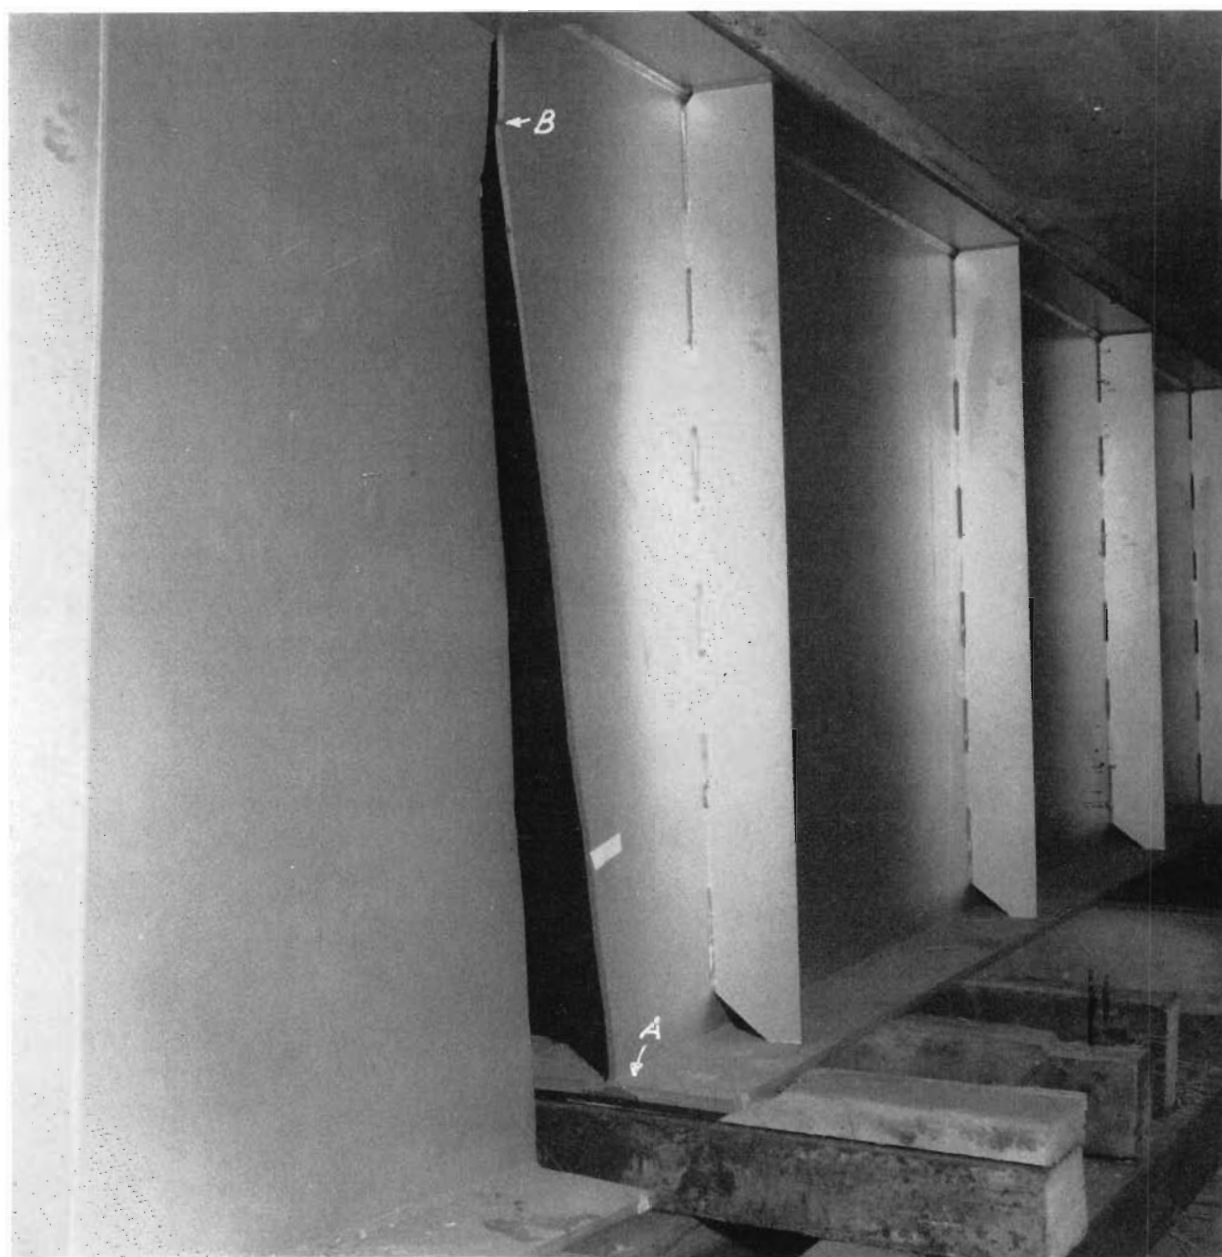
3. At some time after the final coat of paint had been applied in January, 1961 two of the primary brittle fractures propagated up the web plates. In girder W.14-2 at the south end the fracture continued 44 inches up the web and completely severed the bottom flange at this point. This girder, therefore, carried no part of the dead load or traffic load.

Fig. 2.
Fracture in girder W.14-2, southern end, looking south.

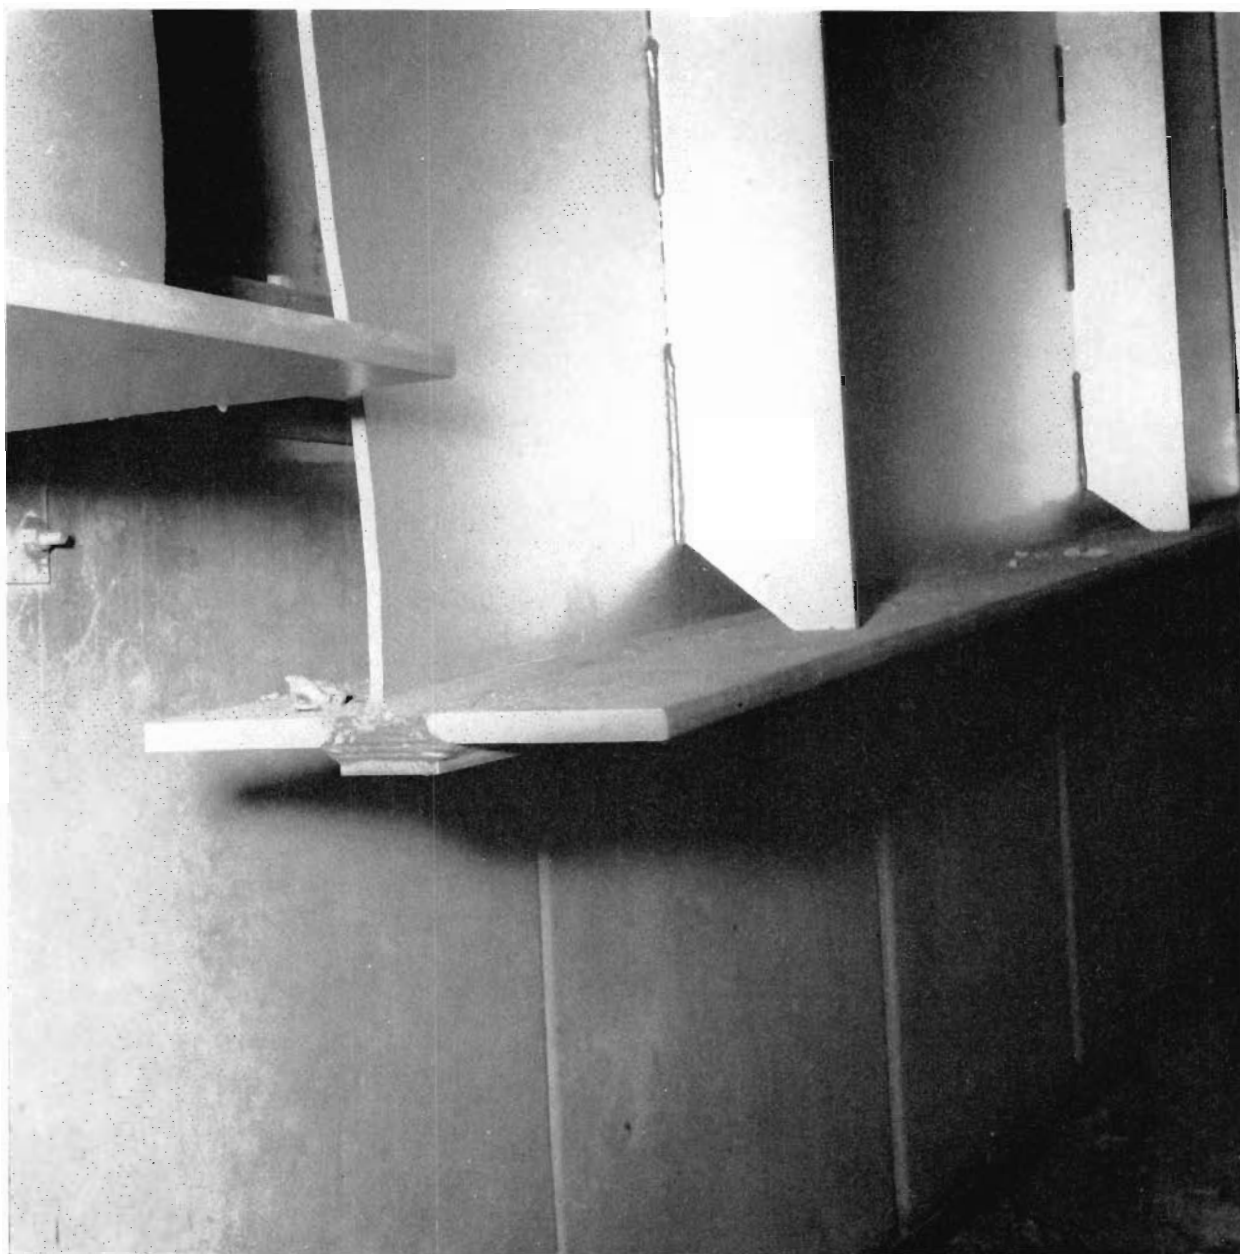
Fig. 3.
Fracture in girder W.14-1, southern end, looking north.

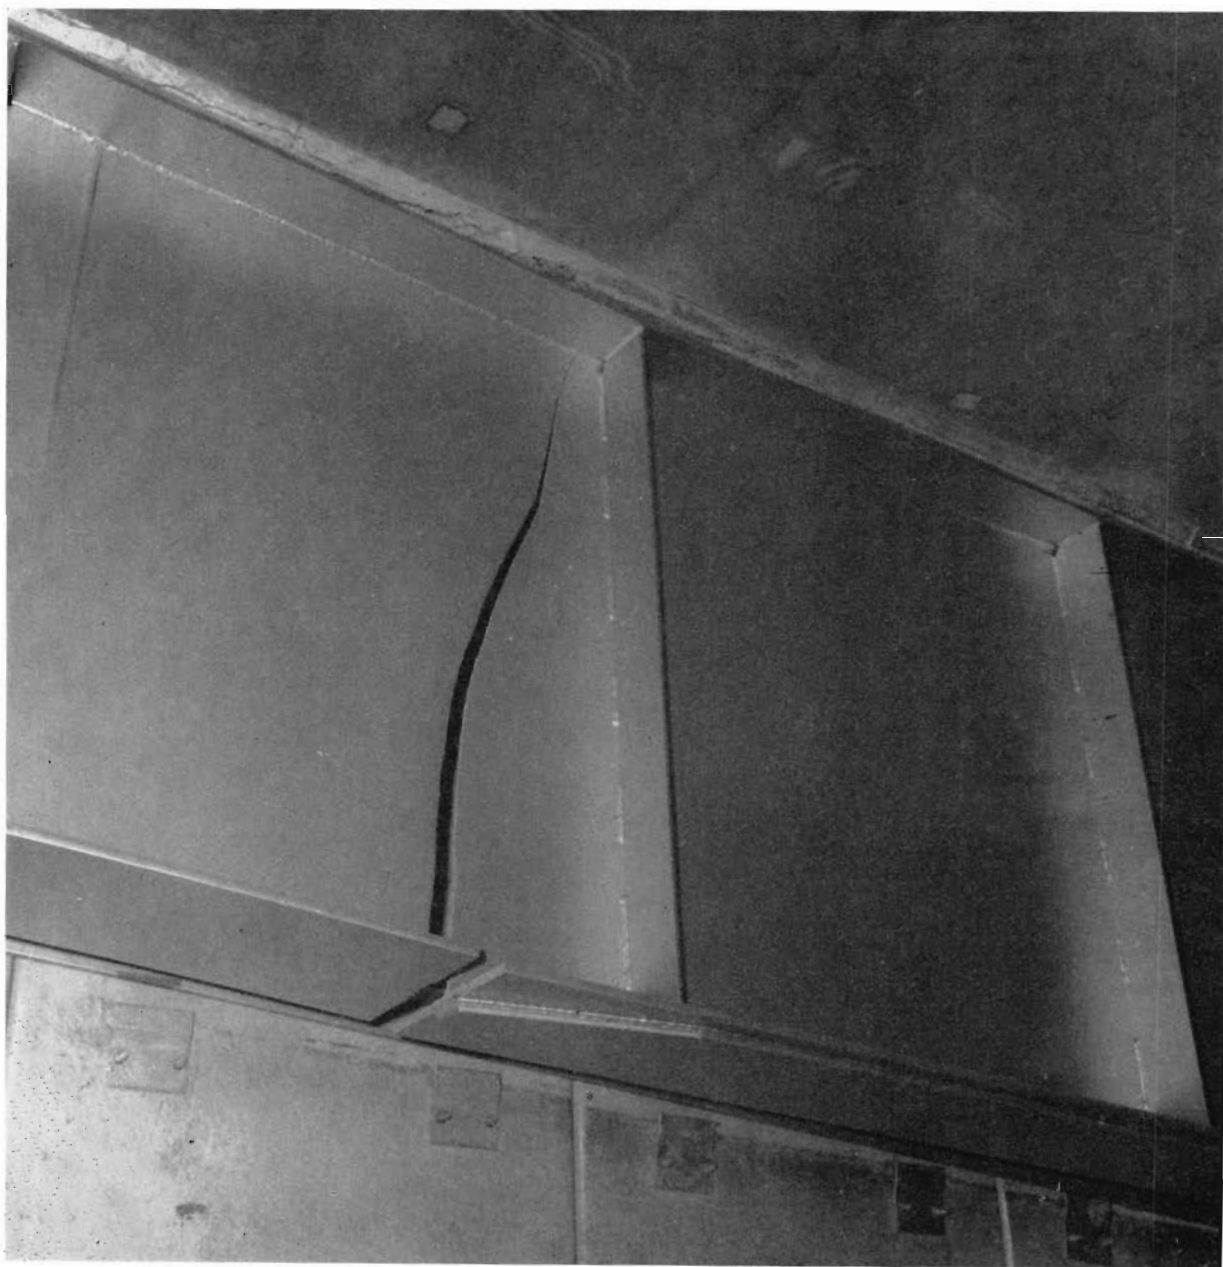
Fig. 4.

Fracture of girder W.14-4, northern end, showing cover plate end.

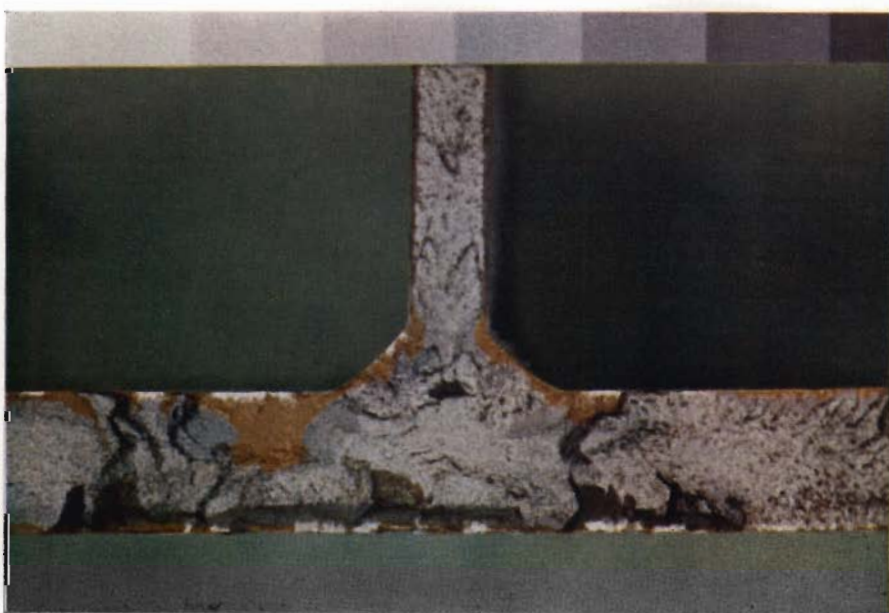
Fig. 8

W14-3 S.Fracture ; South Surface
 Red=Priming Paint. White=Final Aluminium Paint.
