1963

VICTORIA

REPORT
OF
ROYAL COMMISSION
INTO THE
FAILURE OF KINGS BRIDGE

ROYAL COMMISSION OF ENQUIRY INTO THE FAILURE OF KINGS BRIDGE

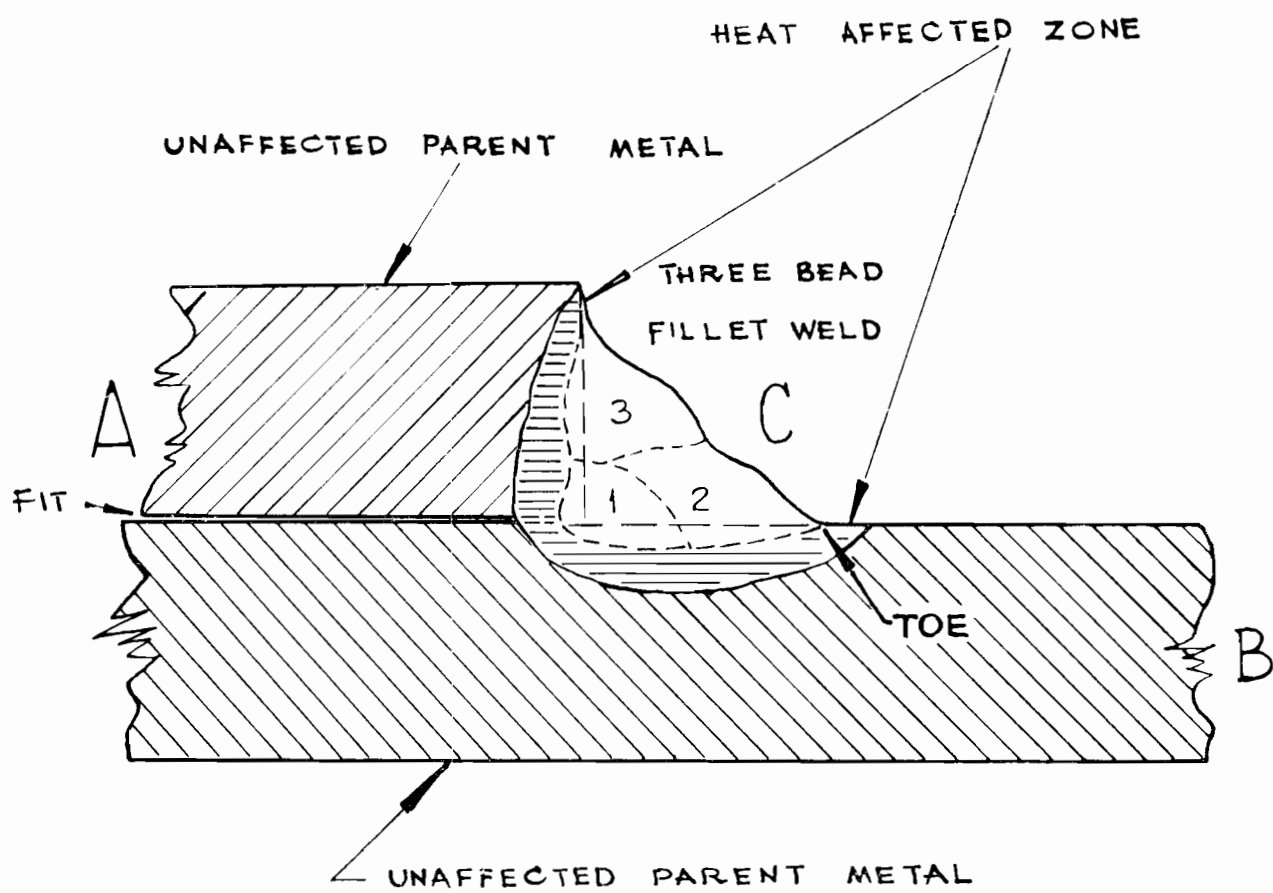
When two pieces of steel A and B are to be welded together, this can be done either by a butt weld or a fillet weld. This latter type, shown at C in Fig. 1, will be used to illustrate the characteristics of welds as it was this kind which was concerned in the failure. The weld shown is a three-bead weld. No. 1 bead is the root run. It is run first and subsequently is covered by and partially incorporated in the two subsequent runs. In a similar way the second run is partially incorporated in the third run. It is an essential feature of a satisfactory weld of this kind that the first run shall fuse into the two plates and that the subsequent runs shall fuse into the first run and into one or other of the two plates. In this way there is formed a continuous metallic union between A and B. Each run or bead is laid down by striking an arc between an electrode and the work being welded. The steel electrode melts and provides the metal of the weld. In general, it is of a different composition from the plates being joined.

This is the heat affected zone (H.A.Z.) of the weld indicated by shading in Fig. 1. The kind of difference in hardness which can be expected with B.S. 968 is as follows (hardness expressed on Vickers Diamond Pyramid scale):—

- Fig. 1. Cross-section through a typical fillet weld and photographs.
- Fig. 2. Fracture in girder W.14-2, southern end, looking south.
- Fig. 3. Fracture in girder W.14-1, southern end, looking north.

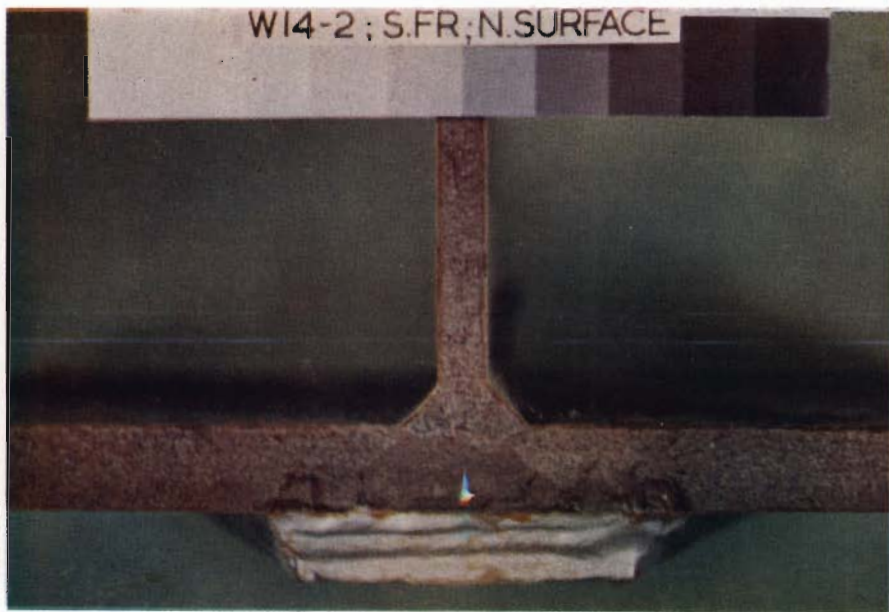
Fig. 5

Figure 5 shows in more detail the nature of the fracture in W.14-2 at the south end. From the bottom is seen—

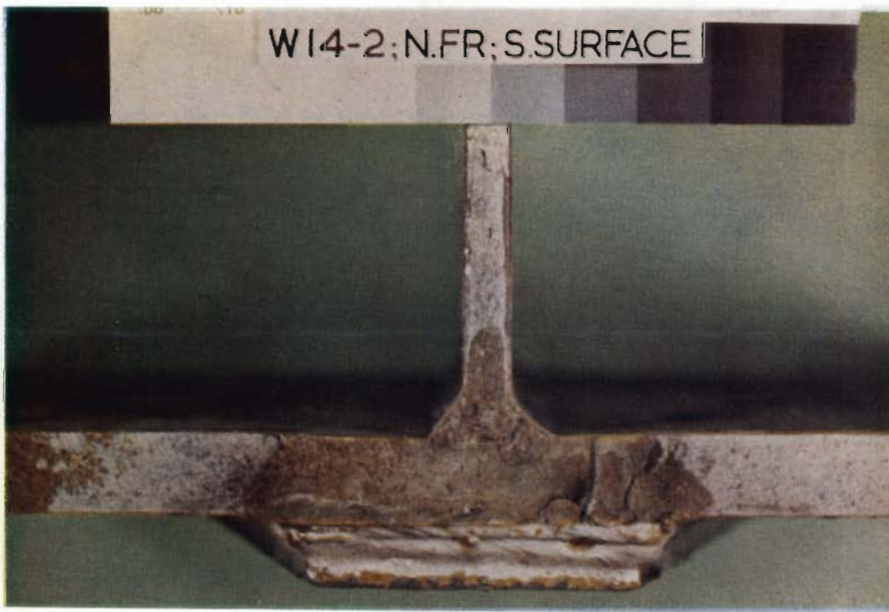
Fig. 7

In addition the north end of W.14-2 had a fracture 1 inch up the web as seen in Fig. 7.

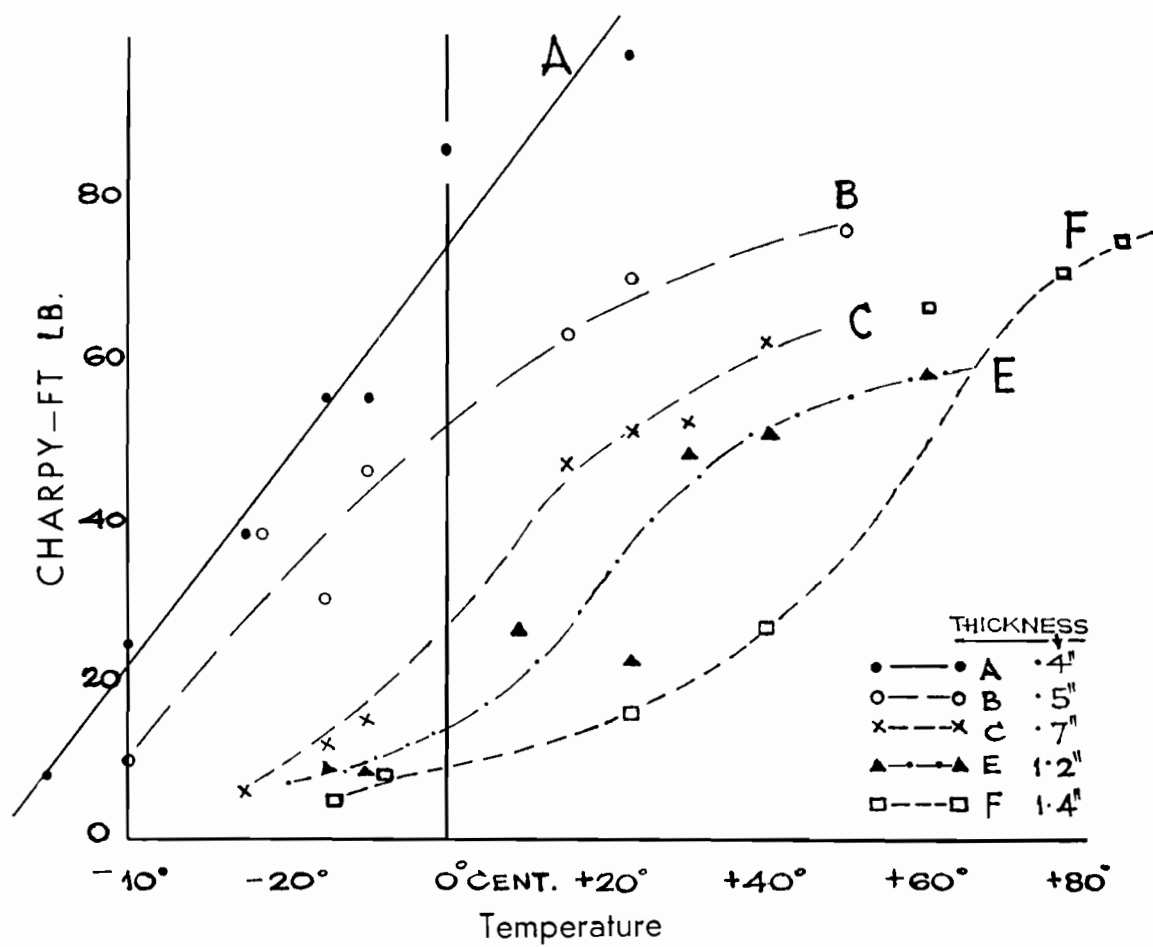
We have for comparison some results from bridge steel made in U.K. at about the same time (1956-57) as the C.R.B. specifications were being written (Ex. 93). For the four thicknesses of steel below 1 inch the values at 0° C. are all above 20 ft./lb. Charpy. Since this is the one valid comparison between B.S. 968 made contemporaneously in U.K. and Australia respectively we have reproduced the results in Figs. 9 and 10. It is at once evident that the transition temperature of the U.K. steel is appreciably lower than that of Port Kembla steel, and the liability to brittle fracture is correspondingly less.

- Fig. 9. Ductility transition curves for B.S. 968: 1941 steel made in the United Kingdom 1956-7.
- Fig. 10. Ductility transition curves for B.S. 968: 1941 steel supplied for Kings Bridge.

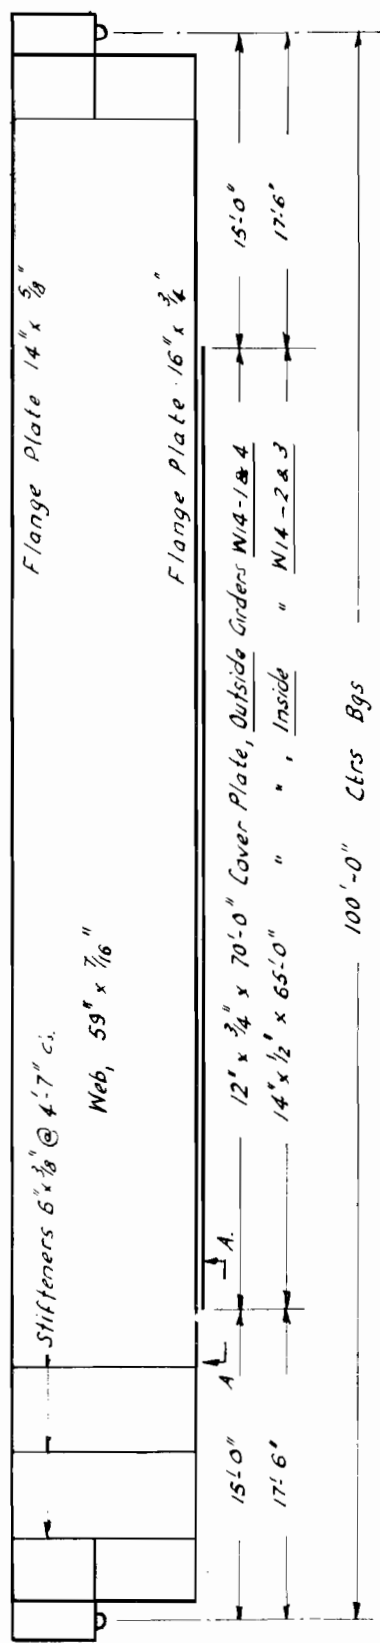
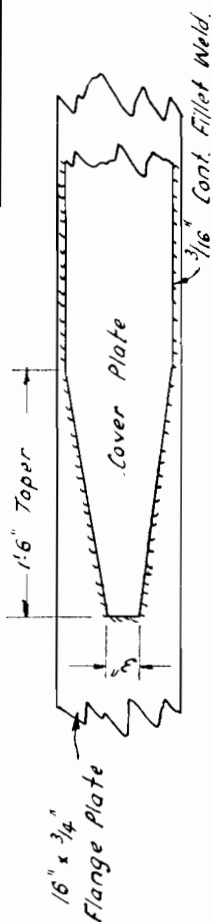
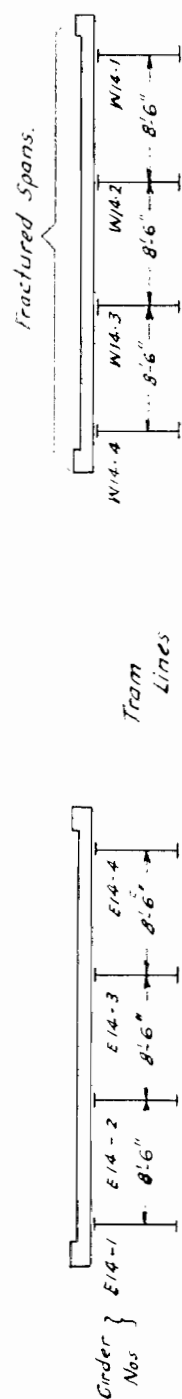
The shape of the cover plate end had also to be decided and here a detail was used that has been successfully used in thousands of instances. It is shown in Fig. 11. In its report (Ex. 1) the Committee of Investigation criticized this detail, saying: "This is known to produce high local concentration of stress and is considered an undesirable feature". The Committee can hardly have been unanimous on this matter, for Exhibit 36 (U.S. Bureau of Public Roads drawing SB-2-53 showing standard Composite I-beam Bridges) shows a cover plate detail almost identical with that used in Kings Bridge and is signed by Mr. E. L. Erickson, a member of the Committee.

Because of the design of the cover plate it was not possible to complete the welding to the flange automatically. At each end there was a tapered part which reduced the width of the cover plate from 14 inches to 3 inches (See Fig 11). These tapered sides and the transverse 3-in. end were welded manually generally using three runs. For this work the Fortrex 35 low-hydrogen type electrode made by Murex was used.

- Fig. 11. Diagram showing main features of the failed girder.
- Fig. 12. Diagram showing the main features of Kings Bridge.
